A **34 year old male** was fatally injured when he was caught in rotating/moving parts of a Wig-Wag machine in a rubber industry.

#### 22 Crushed caught in --- Inspection #1314665 Specialty Tires

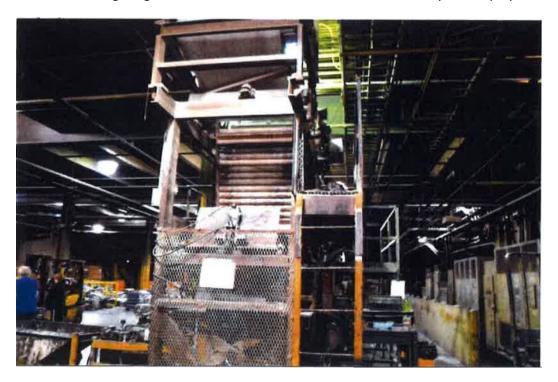
Photo shows Wig-Wag machine. This was the area that was accessed by the employee.

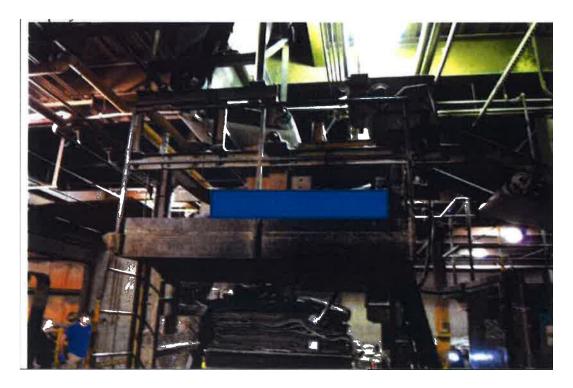
Photo shows Wig-Wag area of the machine. This was the working surface the employee used to access the machine.

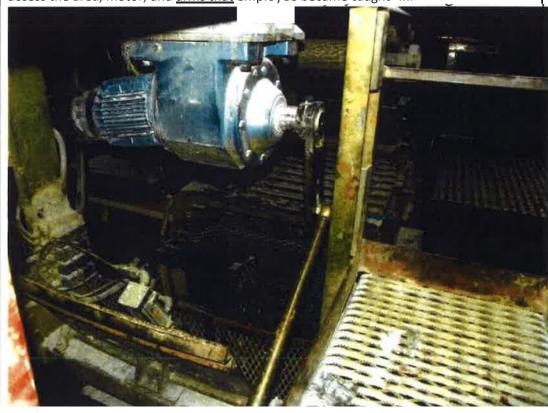
At that time, the machine began movement and caught him in the moving arm that was powered by a Sew-Eurodrive (1720 rpm) motor. This motor drives the stacker arms which move in lateral and longitudinal direction to move the stacker pendulum. This stacker pendulum automatically activates when rubber product reaches the cooling area and the rubber begins feeding into the stacker pendulum. One arm operates in a circular motion around the motor, while the second arm which is attached to the first, swings the pendulum stacker from side to side. The victim's head and right arm were caught-between the two arms, the motor, and the platform he was standing on.

Photo shows area of the Wig-Wag machine where employee entered to repair a bolt below the motor area. Photo also shows the platform that the employee used to access the area, motor, and <u>arms that</u> employee became caught -in.

In that the employee failed to utilize an energy control procedure to ensure employees are protected from the unexpected startup or release of stored energy when performing maintenance tasks on the VMJ SA-30 Straight Line Stacker Assembly (aka the Wig-Wag machine) in the mixing department.
